Manhole Inspection Summary

Manhole # S41GG_028MH

Insp Date: **3/19/08 10:47 AM**

Location Address: **1403 PRESTON ST**

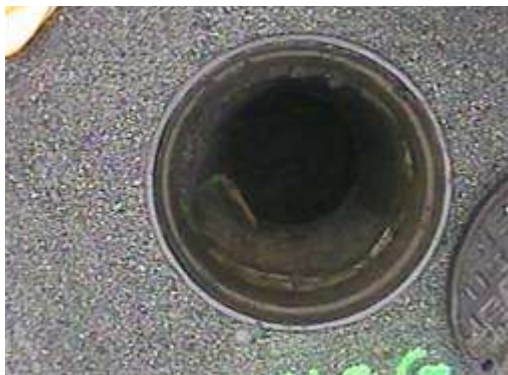
Top View

Condition: ☐ Sound ☒ **Cracked** ☐ Root Intrusion ☐ Loose Brick ☐ Deteriorated

Count: **1** Missing: **3** ☒ **Corroded**

cracked chimney and corroded steps

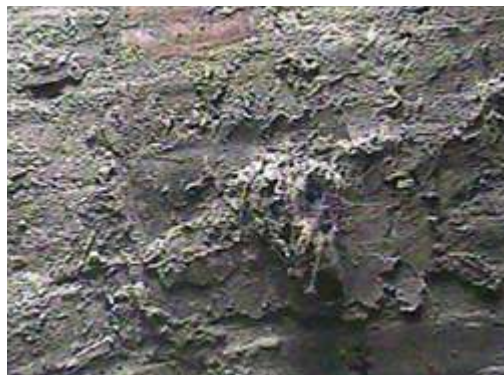
Comments **POSSIBLE ILLICIT CONNECTION - SEE PHOTO**

POSSIBLE ILLICIT CONNECTION

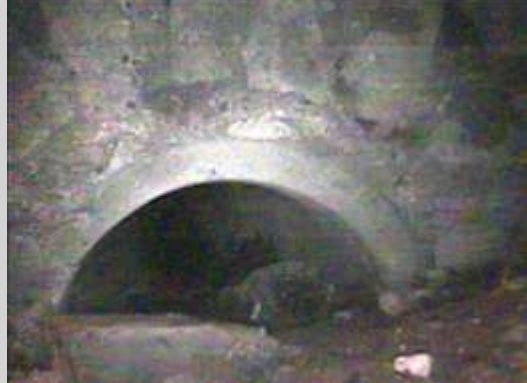
12 O'Clock Outflow

8 in. Circular Gravity Sewer
Pipe Out @ 12 O'Clock

Deposits: ☐ None ☒ **Mud** ☐ Sludge ☒ **Debris** ☐ Grease

Silt Depth: **4** (in.) Deposits Extent: **Medium**
